BRIDGE SUMMARY SHEET

District: 16 County: 137 Control - Section: B008 - 40 Structure #: 001 Route: 6TH STREET
 Feature Crossed: TRANQUITAS CREEK Inspector's Signature: Bill Tankersley Date: 3/8/2021
 Company Name and Company Number: Yvonne Newman Engineering, Inc. [F-101] Bridge Owner: City of Kingston

BRIDGE INSPECTION RECORD

Bridge Description:
6 Simple Span Concrete Slab Bridge on Concrete Pile Bents

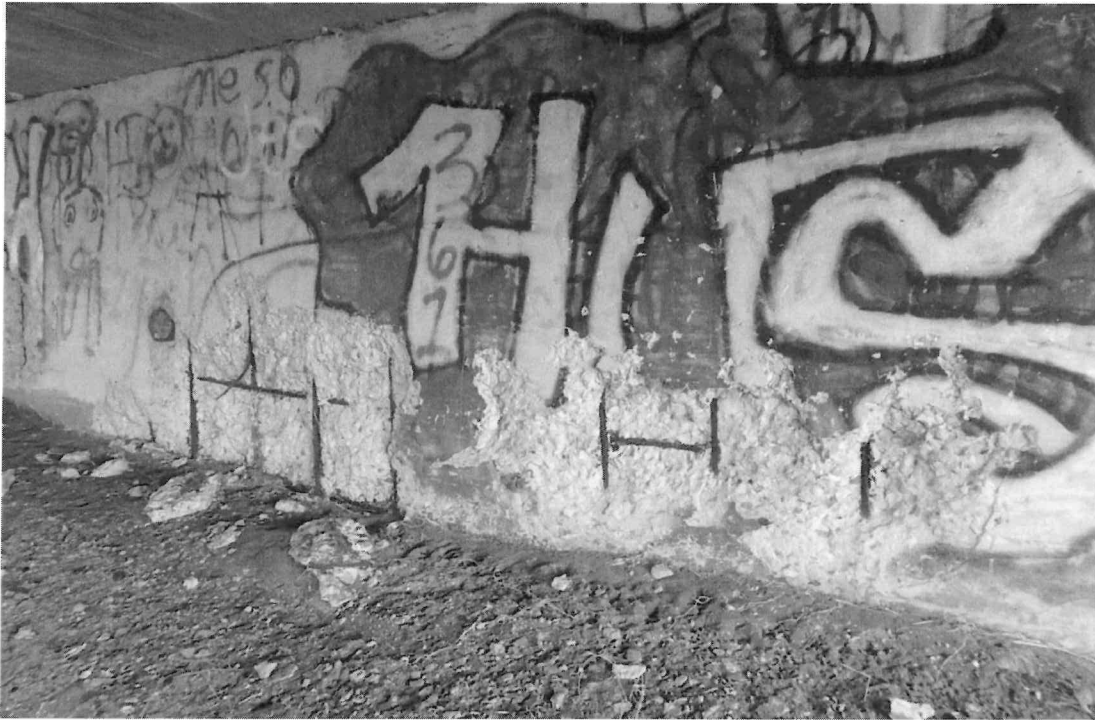
Component	Description	Min.	Rating	Comment
Abutment Caps		0	N	
Above Ground		0	6	Moderate spalling (~50 sq. ft.) with exposed & slightly corroded rebar in south abutment wall. (photo) Minor honeycombing in south abutment wall as well. Minor vertical cracking (< 1/8 in. wide) in abutment walls.
Below Ground or Foundation		0	8	
Backwalls & Wingwalls		0	7	Minor spall in NW wingwall adjacent to edge of slab. Minor hairline cracking in SW and NW wingwalls.
Intermediate Supports:				
Caps - Concrete		-	6	Minor delamination & spalling along top edges (bearing areas) of original pier walls & widened cap beams at the 2 south bents. (photo)
Caps - Steel		-	N	
Caps - Timber		-	N	
Above Ground - Concrete		-	6	Minor scaling & honeycombing along base of concrete pier walls & piles for interior bents.
Above Ground - Steel		-	N	
Above Ground - Timber		-	N	
Above Ground - Masonry		-	N	
Below Ground or Foundation		-	8	
Collision Protection System		5	N

VIEW 7 - SEVERAL MODERATE SPALL WITH EXPOSED REBAR IN SOUTH ABUTMENT WALL

2. Remove loose and delaminated concrete from pier walls and south abutment wall then clean and patch spalls. 04-09-2021

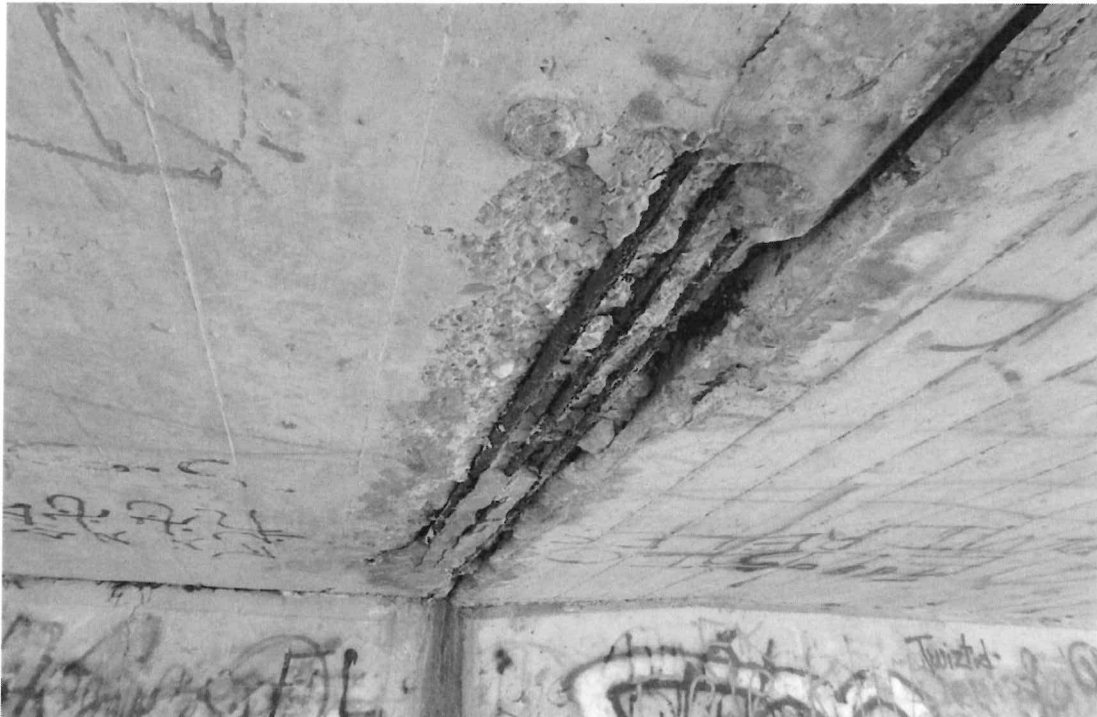
Component	Description	Min.	Rating	Comment
Main Members - Steel		0	N	
Main Members - Concrete		0	6	Moderate delamination & spalling with exposed & slightly corroded rebar in soffit of flat slab along widening joint at centerline - condition worse in north span (~9 sq. ft.) (photo).

VIEW 8 - HEAVY SPALL WITH EXPOSED REBAR IN SOFFIT OF SLAB IN NORTH SPAN ALONG CENTER WIDENING JOINT.

1. Remove loose and delaminated concrete from soffit of flat slabs. Clean and patch all resulting spalled areas.

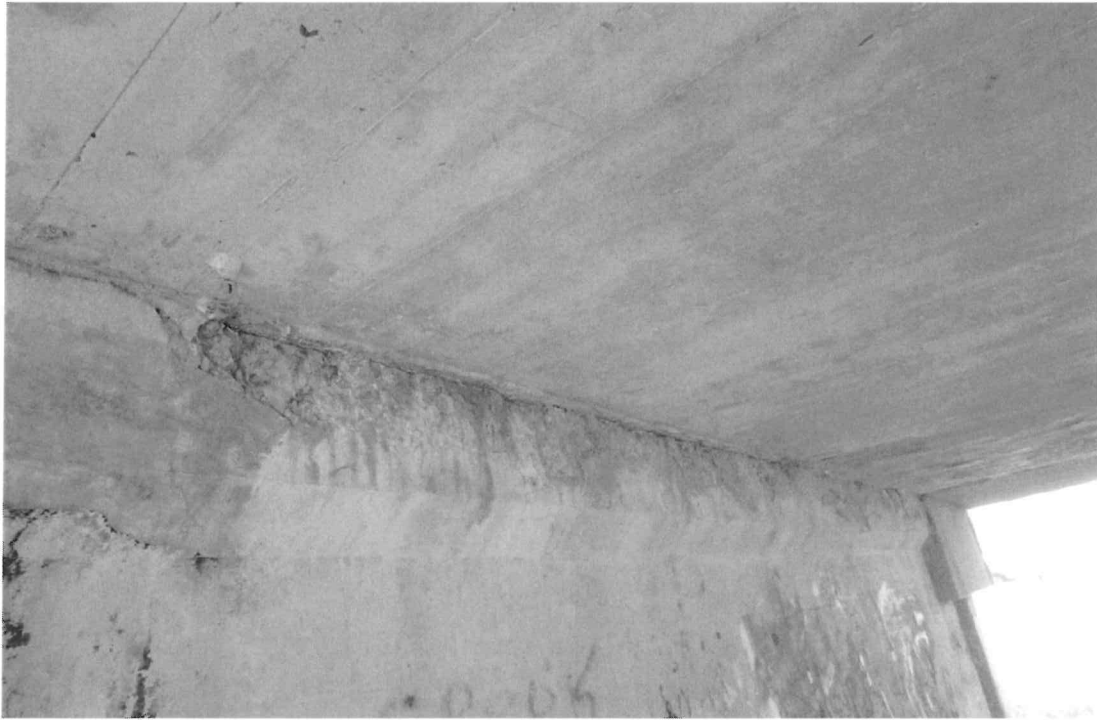
**VIEW 9 - MINOR DELAMINATION & SPALLING ALONG TOP EDGES
(BEARING AREAS) OF ORIGINAL PIER WALLS & WIDENED CAP
BEAMS AT THE 2 SOUTH BENTS.**
